SERVICE BULLETIN

Classification: EL01-012	Reference: NTB01-037	Date: June 1, 2001
-----------------------------	-------------------------	-----------------------

2000 MAXIMA DRIVER'S FRONT POWER WINDOW - NO OPERATION

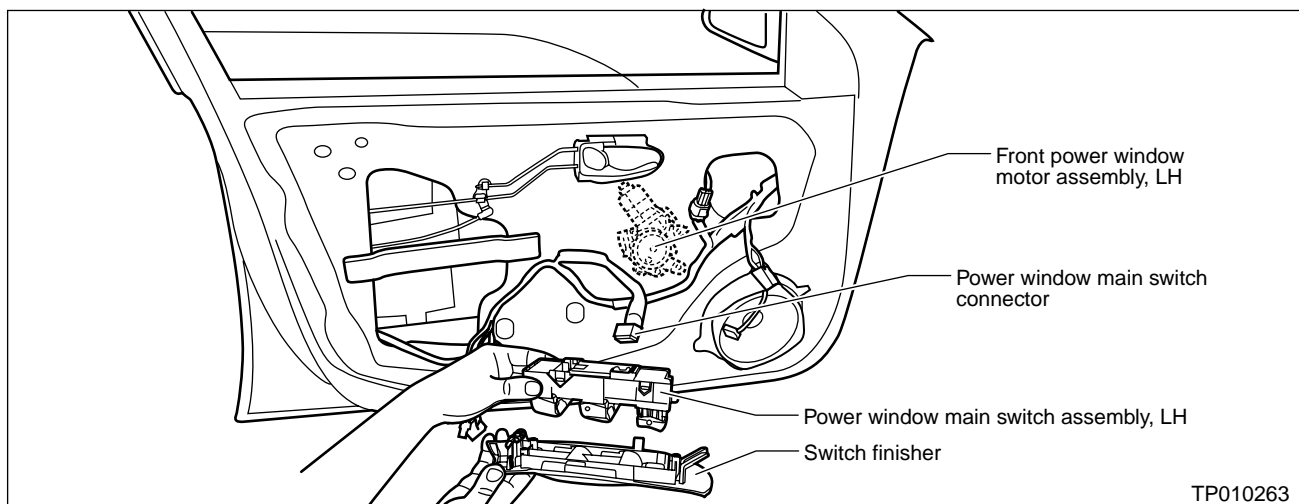
The auto up/down function of the front, left-hand power window main switch may be intermittently jamming or sticking, causing the left-hand power window motor assembly to stop working.

If an Applied 2000 Maxima needs power window motor replacement, the power window main switch assembly should also be replaced with one from the PARTS INFORMATION section of this bulletin. See Figure 1 for location of the front, left-hand power window motor assembly and power window main switch assembly.

1. Confirm that the front, left-hand power window is not operating.
2. Using the EL section of the appropriate Service Manual, diagnose the power window circuit.
 - If the Trouble Diagnosis section indicates motor replacement, proceed to Step 3 below.
 - If the Trouble Diagnosis section indicates cause(s) other than the motor, repair as needed.
3. Remove the power window main switch assembly from the switch finisher.
4. Disconnect the switch assembly.
5. Replace the power window motor assembly.
6. Re-connect the switch assembly.
7. Verify proper operation of the power window.
8. If the vehicle was built before the APPLIED VINS/APPLIED DATE listed on page 1 of this bulletin, replace the power window main switch assembly also.
