# SERVICE BULLETIN

Classification: <b>FA00-003a</b>	Reference: <b>NTB00-030a</b>	Date: <b>June 19, 2000</b>
-------------------------------------	---------------------------------	-------------------------------

## 2000 MAXIMA RIGHT FRONT STRUT NOISES

**APPLIED VEHICLE:** 2000 Maxima (A33)

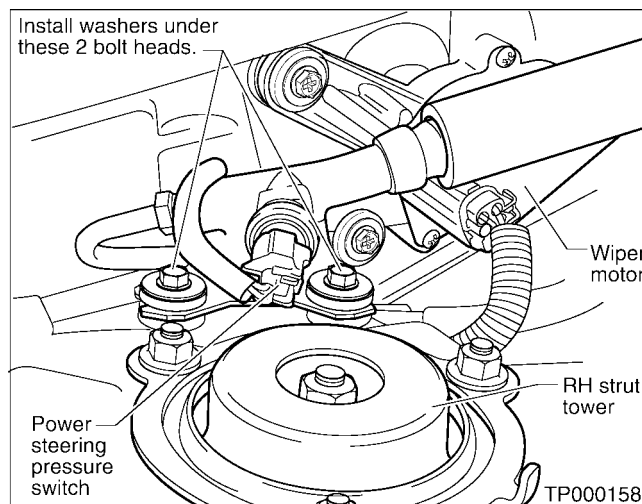
Figure 1

- Click or clunk noise from the right side when turning right. This may be caused by contact between the tip of the power steering switch bolt(s) and the RH upper spring seat.
- Squeak or squish noise from the right side when applying the brakes. This may be caused by spring/seat contact in the RH strut assembly.

1. Add one washer to each bolt for the power steering switch bracket (see Figure 1).
