2000-2002 MAXIMA, 2000-2001 I30 OR 2002 I35; WINDOW REGULATOR GEAR GRINDING NOISE

Service Information

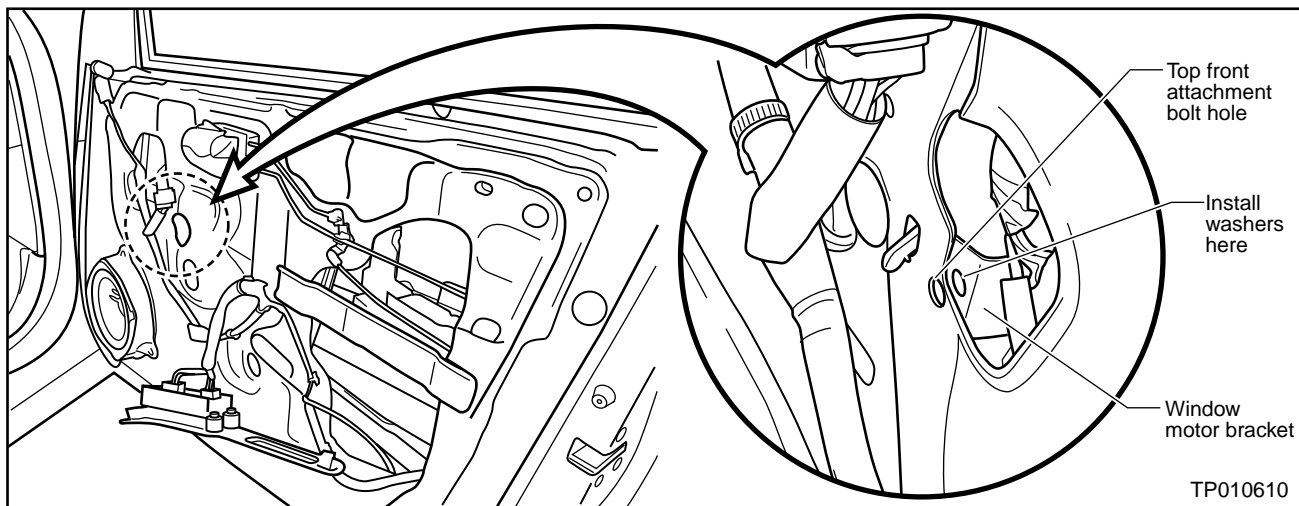
Figure 1

The noise may be due to the alignment of the window regulator/motor sub assembly, where it attaches to the inner door panel. Refer to the Service Procedure in this tip to repair the incident, if it should occur.

1. During window operation, duplicate and identify if the noise is a squeak/scraping and/or a gear/grinding type noise.
2. If it's a squeaking or scraping type noise this procedure does not apply. For a gear/grinding type noise continue on to step #3.
3. Remove the incident window side door panel, then remove the top portion of the vapor barrier to gain access to the window regulator/motor attachment bolts.
4. Loosen, but don't remove, all three (3) bolts at the window regulator/motor assembly.
5. At the top front attachment bolt install two (2) washers, each one 2mm thick, in between the window motor bracket and the inner door panel (see Figure 1).

6. Retighten the three (3) window regulator/motor attachment fasteners.
7. Reconnect the power window switch and confirm the gear/grinding noise has been eliminated after shimming the window regulator/motor assembly.
8. Reassemble the door/door panel.
9. Reconfirm the gear/grinding noise is no longer present.
