## SUNROOF MOTOR RESETTING PROCEDURE

### Service Information

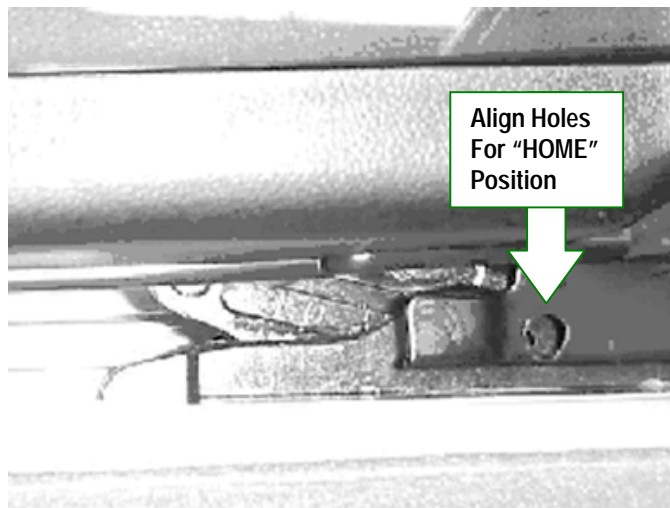
Figure 1

1. Line up the holes in the sunroof linkage to find the "Home" (closed) position (see Figure 1).

2. Replace the sunroof motor assembly.
3. Disconnect the battery for at least two (2) minutes.
4. Reconnect the battery.

NOTE: Do not use the Auto Open/Close feature for step 5.

5. Cycle the sunroof manually to the full open, then full closed positions.
